Technical Bulletin

Ref: **TB-18001-ENG**

Product: INOMAX[®] Cylinders / INOmeter[®], INOflo[®] Cylinders

Subject: **Opening the INOMAX Cylinder Valve for Therapy**

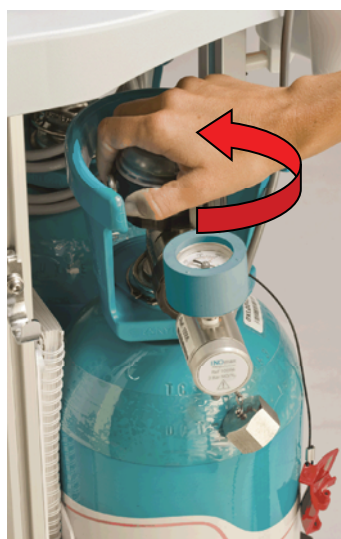
CP.P.0017

The cylinder regulator may not provide adequate gas pressure and flow if the cylinder valve is only partially open, leading to under delivery or interrupted delivery due to a “Low Cylinder Pressure” or “Low NO/N₂ Pressure” alarm. Partial cylinder valve opening can occur if users watch the cylinder valve handle icon on the monitor screen while opening the cylinder valve, and then discontinue rotation when the cylinder handle icon first appears green as opposed to fully opening the valve.

Figure 1 Rotating cylinder handle counter-clockwise

When opening the cylinder valve to start therapy, it is very important to rotate the cylinder valve handle until resistance to further movement is felt indicating the valve is fully opened (see Figure 1 below).
